Name Of Dam: GEORGE F. BRASFIELD

Location: DINWIDDIE/CHESTERFIELD COS. VIRGINIA

PHASE I INSPECTION REPORT

NATIONAL DAM SAFETY PROGRAM

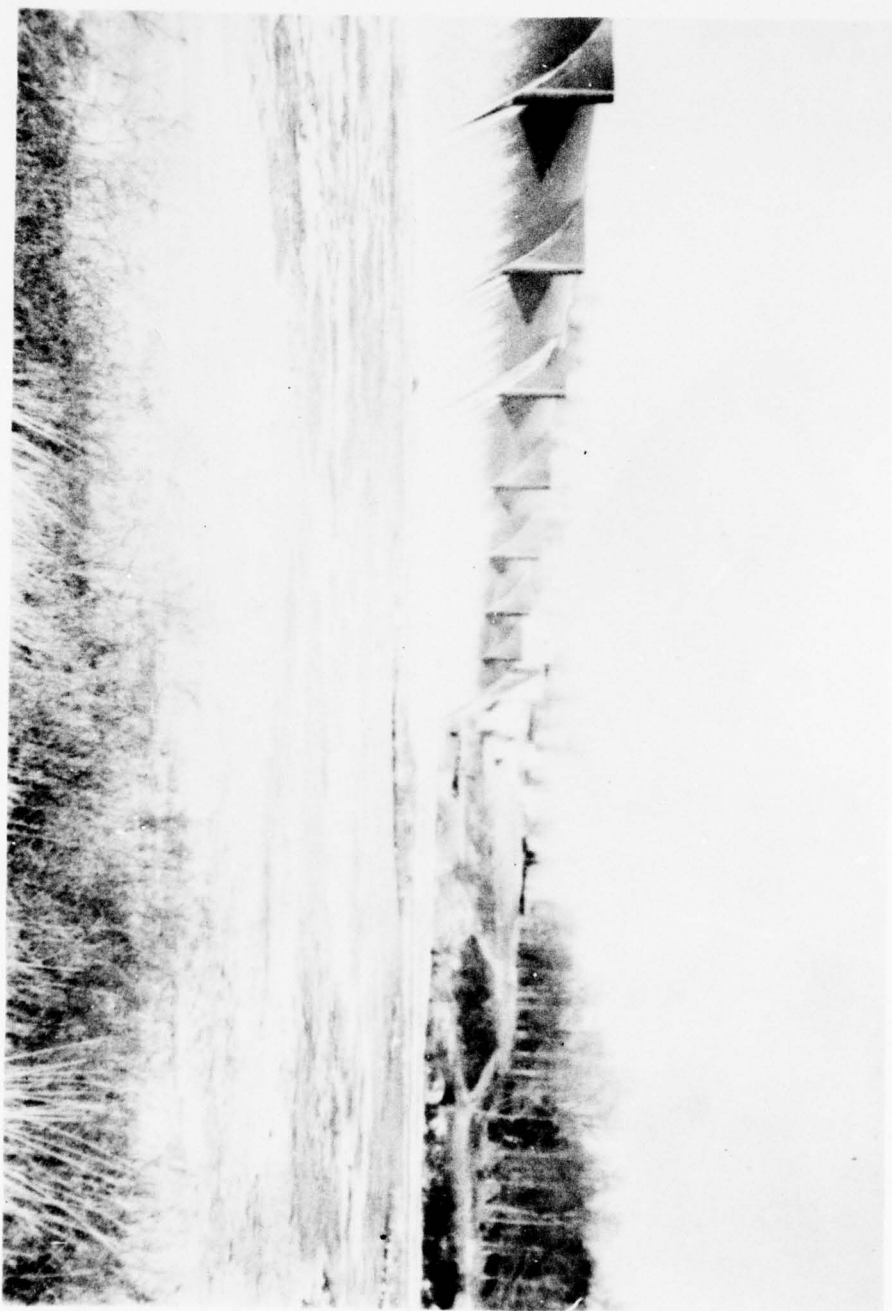
GOERGE F. BRASFIELD - OVERVIEW PHOTO
FROM D/S OF RIGHT ABUTMENT

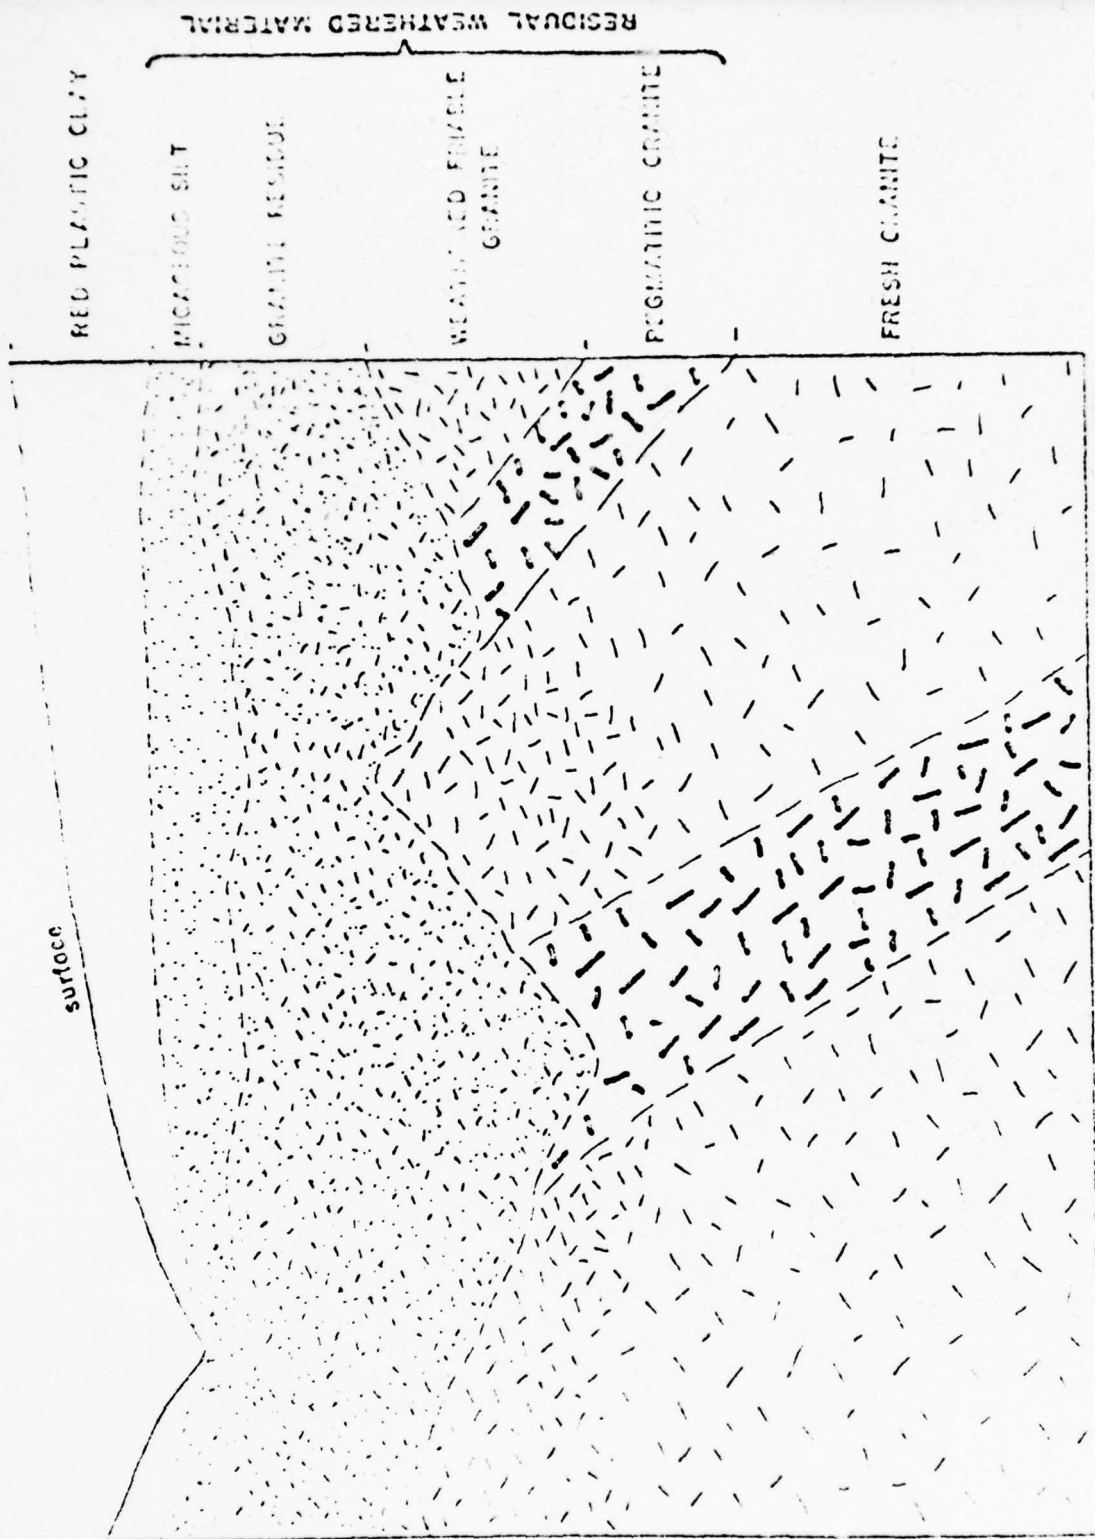
As shown in Figure 1, the normal soil profile is divisible into several zones. The topsoil which is humus-bearing is sandy and in most places is not over 2 feet thick. Immediately underneath it is a zone of plastic red clay which is breached generally in the bottoms of the short tributary gullies in either valley wall. The red clay layer is 1 to 15 feet thick. Directly under this zone is a body of gray disintegrated granite which has the general texture and consistency of sawdust when disturbed but which in the undisturbed condition is reasonably tight and coherent. The upper contact of this zone is sharp, but the lower one is gradational down into weathered friable granite bedrock--some of which is soft enough to be broken by hand in the core samples.

Figure 1.- Diagrammatic profile of weathered zone on the Petersburg Granite in cross of BL-2 base line across Appomattox River.

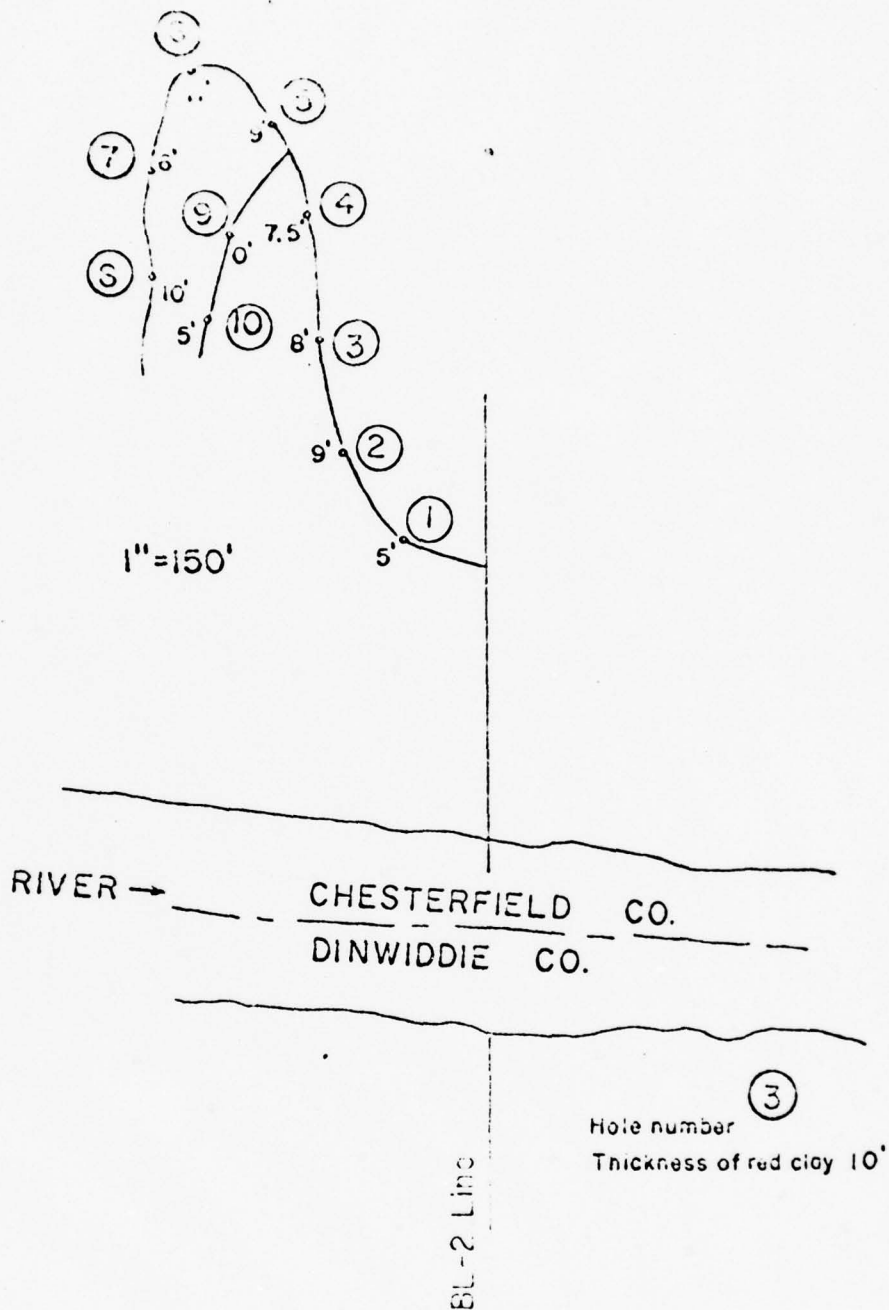
Figure 2.—Sketch of auger holes with thickness of red clay encountered—

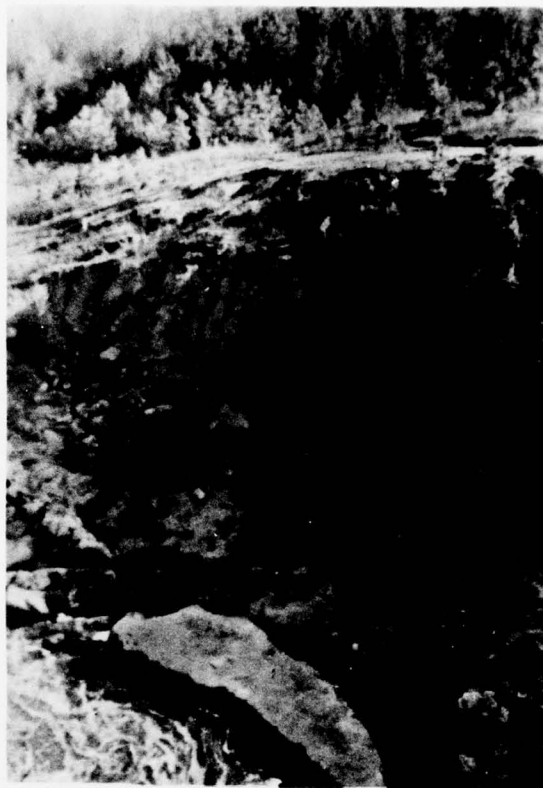
3.3.2 Abutments: The erosion on the downstream slope of the right abutment is considered a problem that will require corrective action. If allowed to continue, the unimpeded erosion could possibly cut the abutment slopes back to the abutment and end of dam contact. This action would result in a shorter seepage path and a possible failure of the abutment. Additional erosion was observed on the upstream shoreline of the left abutment. This erosion can be corrected by the use of approved shore protection.

1.2.1 Observations: The abutments of the concrete dam are composed of weathered granite and residual clays. A majority of the abutment slopes are grassed. Despite the grass cover, serious erosional gullies have developed on the downstream slope of the right abutment. This erosion has steepened the downstream slopes (lv to lh) and reduced the fill adjacent to the dam. In addition to the erosion, minor shoreline erosion was noted on the upstream slope of the left abutment.

GEORGE F. BRASFIELD - VIEW OF BANK EROSION ON D/S SLOPE
OF RIGHT ABUTMENT

1.2.2 Recommendations: The erosion on the downstream slope of the right abutment should be corrected immediately to prevent further deterioration of the abutment. In addition to grading and seeding, a paved channel should be constructed to divert surface runoff from the upper slopes to the river. The erosion of the upstream shoreline adjacent to the dam can be arrested by the use of rip-rap and filter cloth.

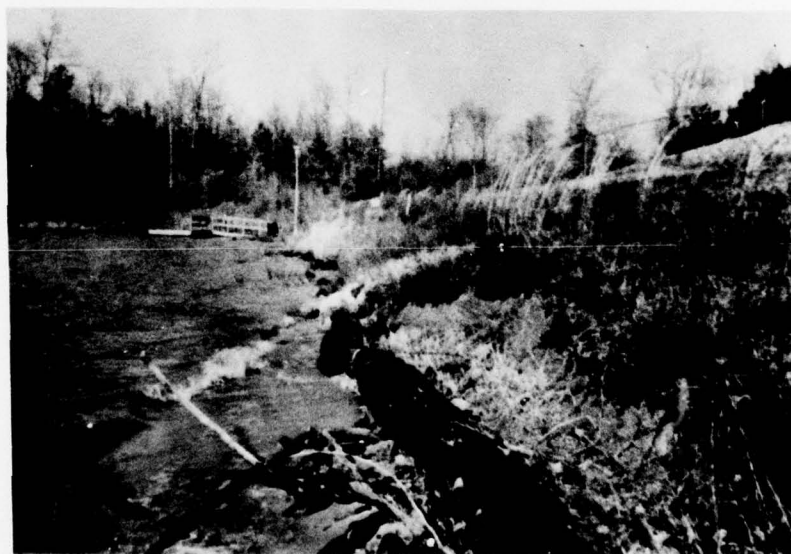
GEORGE F. BRASFIELD - VIEW OF BANK EROSION ON U/S SLOPE
OF LEFT ABUTMENT
